## PROJECT 10073 RECORD

PHOTO ANALYSIS REPORT

NR 67-54

SUBJECT UNIDENTIFIED FLYING OBJECT

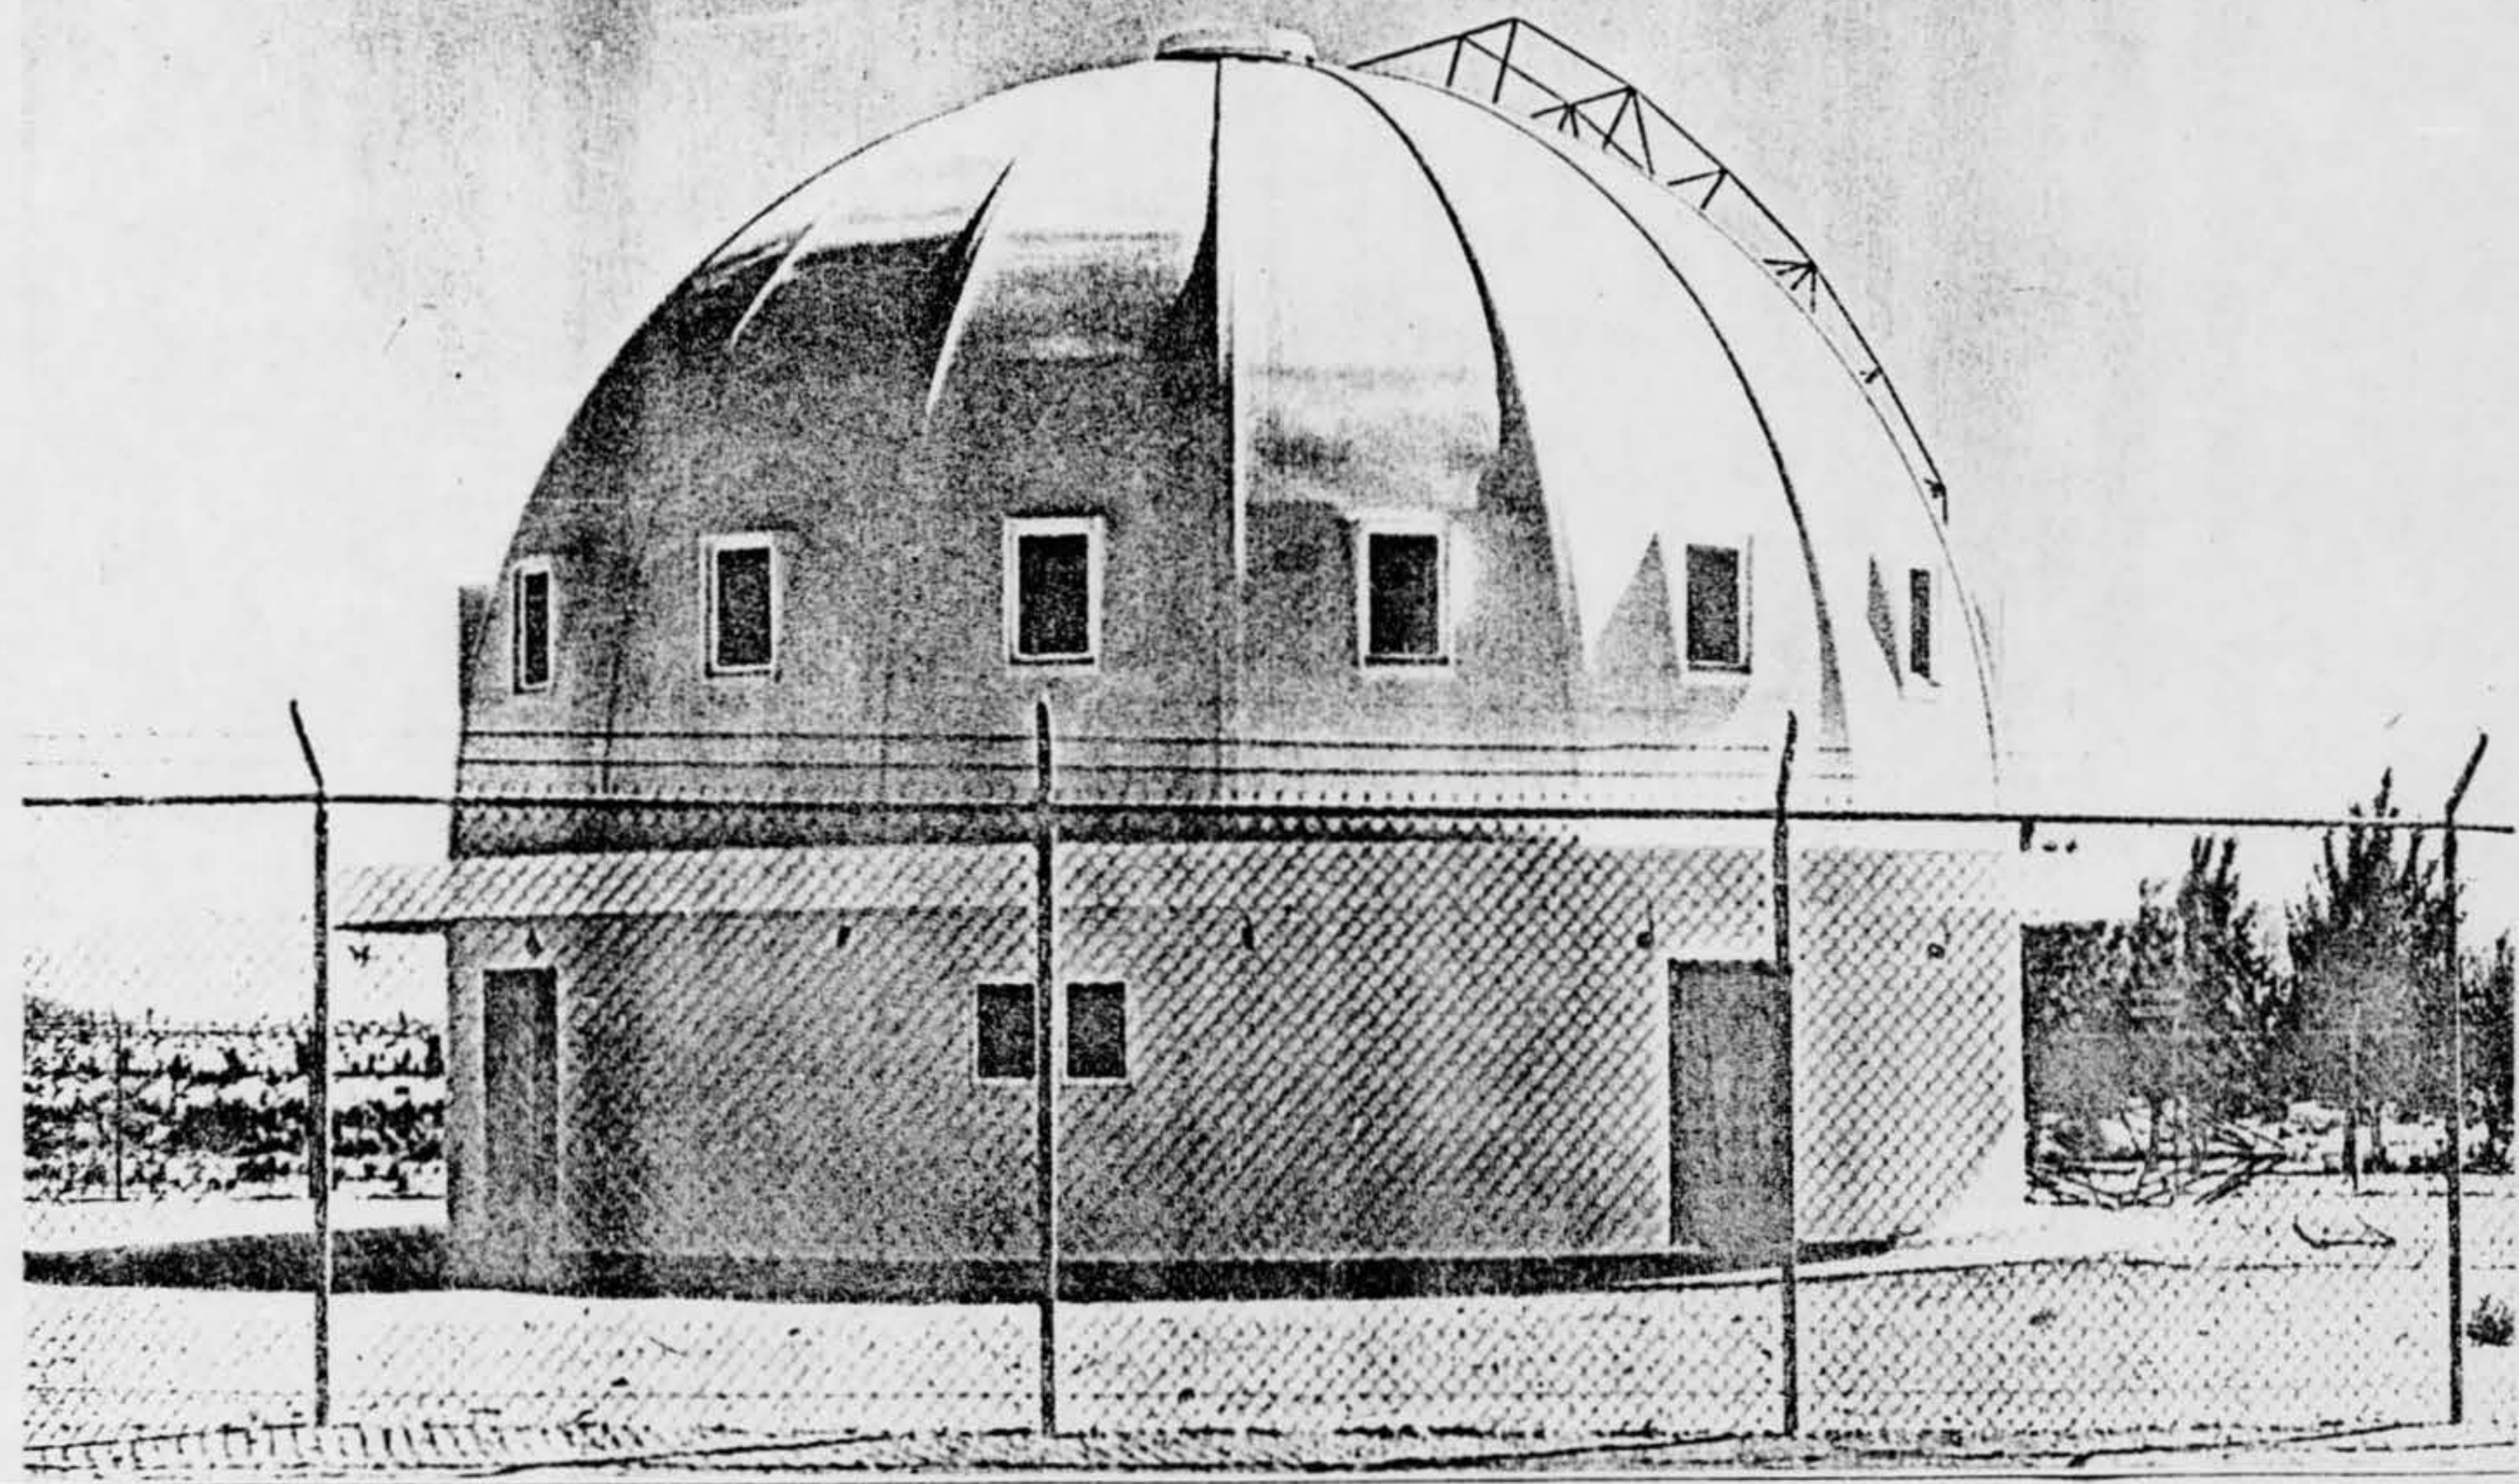
2. ANALYSIS: The object cannot be definitely identified. There is the possibility that it could be a film processing defect, such as a bubble in the developer, or a light reflection. An analysis of the original negative could possibly reveal new information which cannot be gleaned from the paper prints that have been made available.

As soon as I inspected the film after its development, I noticed a donut-shaped object in the sky above the building's dome. It appeared to be an undeveloped spot surrounded by a clear area. Naturally, the clear area appears as a black ring in the finished print.

My first reaction was to conclude that somehow the developer had failed to reach that spot and that the result was a flaw on the negative. Perhaps, I thought, that portion of the film had been touching another spot on the same roll as it lay coiled in the development tank. But no corresponding flaw appears anywhere else on that roll. The tank used, incidentally, is a 16 oz. Nikor, designed to hold one roll of 120 film.

(1) If the white spot is the result of lack of development, what is the explanation for the clear ring (clear on the negative, that is) surrounding it?

(2) Instead of being clearly defined around the edges, as might be expected of a spot caused by chemicals, this spot is fuzzy around the edges, as might be expected in the photograph of an object in motion.

I still think the "object" shown in this picture is the result of some accident during development, but because of the factors listed above I am submitting this print for your opinion and for insertion in your files. If you would like to see the negative as well, please let me know and I'll send it to you.
