UNIDENTIFIED FLYING OBJECTS (UFO) FILES

File Number: AIR 1080 / 6 / 897 Volume 1

**File Title: Investigations of Unidentified & Radar Sightings
East Coast South Island – December 1978**

File Contains: Interviews with people involved in the 1978 Kaikoura sightings conducted by the RNZAF preparatory to the preparation of a formal report into these sightings. File also contains technical reports from DSIR and other scientific experts and an independent report of the Kaikoura sightings by the NZ UFO Studies Centre.

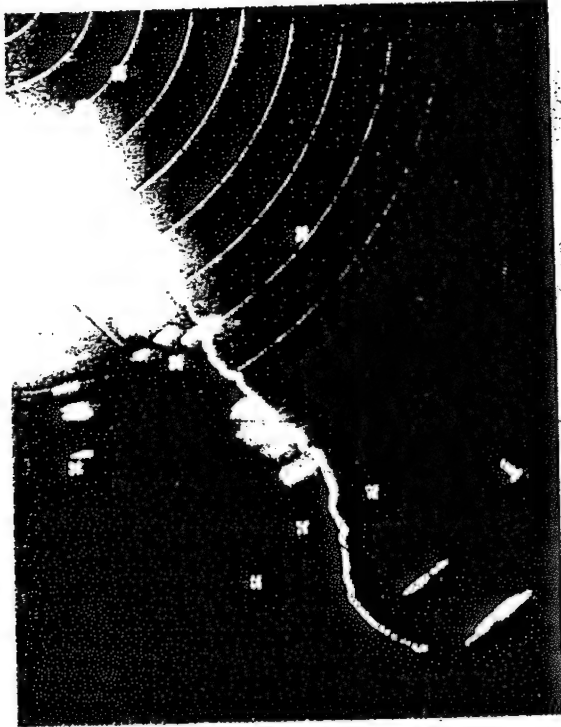
0333. RAW VIDEO. 160 MI.
BANKS PENINSULA RETURN
AT MAX^M RANGE

TWO ANOMALOUS ECHOES
15 MI. NORTH OF BANKS P.

The most interesting example was seen to be moving radially outwards at 172° at an erratic 100-150 knots for 10-15 minutes. It was 50-60 N.MILES from Wellington. Although we did not notice when it first became visible, it disappeared quite quickly at about 0445.

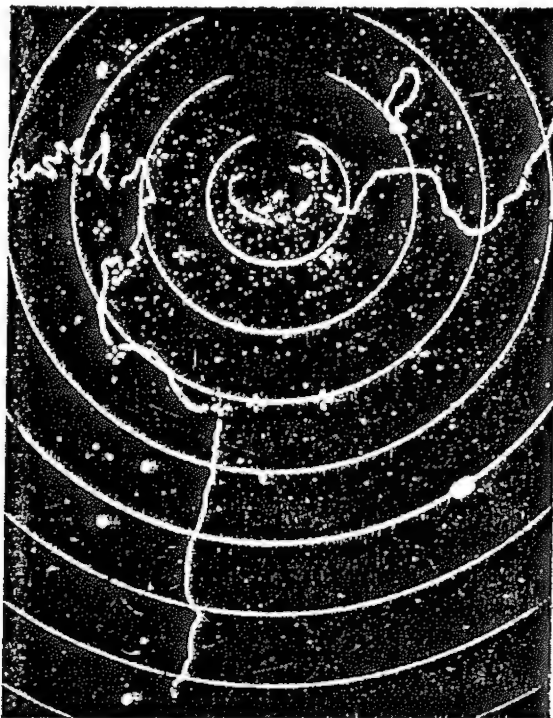
0430. M.T.I. 10 MI CIRCLES

SHIP OFF SOUNDS 36 MI.

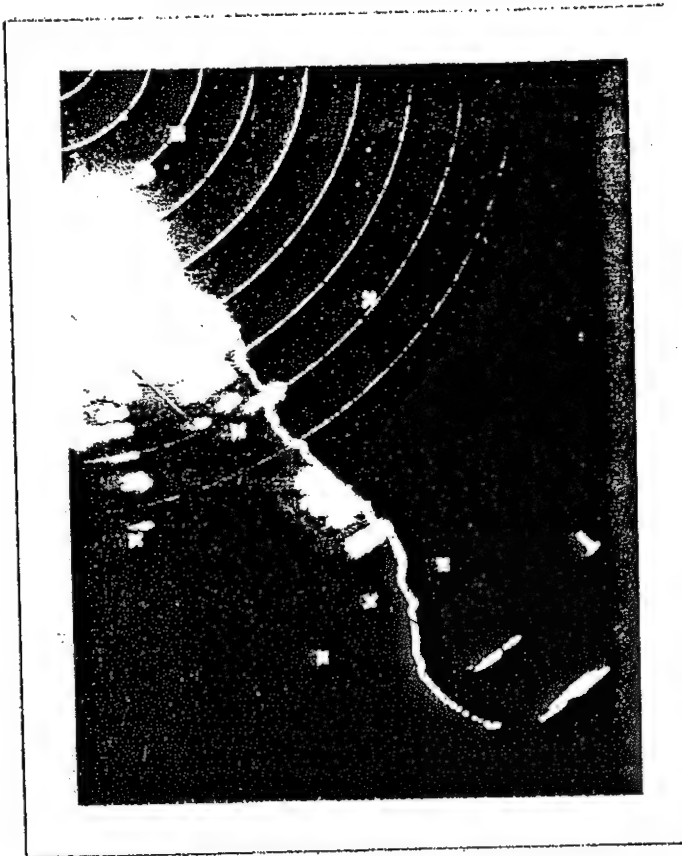
0333, RAW VIDEO, 160 MI.
BANKS PENINSULA RETURN
AT MAX^m RANGE

TWO ANOMALOUS ECHOES
15 MI. NORTH OF BANKS P.
