NARCAP Technical Report 10  
NARCAP TR 10, 2007

Report of an Unidentified Aerial Phenomenon  
and its Safety Implications at O'Hare International Airport  
on November 7, 2006

Richard F. Haines, Senior Editor  
Chief Scientist

May 14, 2007

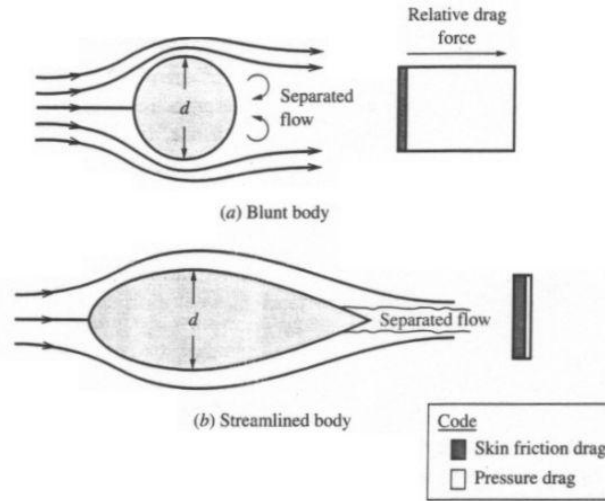
Figure 14. Comparison of viscous and pressure drag for blunt and streamlined bodies.

Thus, about 59% of the freestream kinetic energy— $29.5 \text{ kJ/m}^3$ —shows up as drag. However, the total drag force is comprised of pressure drag and viscous, or friction drag. Pressure forces are recovered in the wake of an object and it is only a portion of the viscous drag component that shows up immediately as localized heating of the air. For blunt bodies, the component of drag due to pressure is very much larger than the component due to viscosity or friction. Fig. 14 gives a graphical depiction of this situation.

Only about 10% of the total drag force of a blunt body moving at subsonic velocities could show up immediately as heat. This means that the presumed oblate spheroid which ascended nearly vertically above Chicago O’Hare on November 7, 2006 could only have provided about  $2.95 \text{ kJ/m}^3$  of heating to the surrounding air due to its kinetic energy. This calculation yields an effect more than 3 times too small to have produced cloud droplet evaporation and provides a semi-quantitative basis for the common sense observation that solid objects such as aircraft, rockets, artillery rounds, and the like do not punch sharp edged holes in clouds. We must look for an evaporation mechanism not limited to the energy transfer mechanism of aerodynamics.

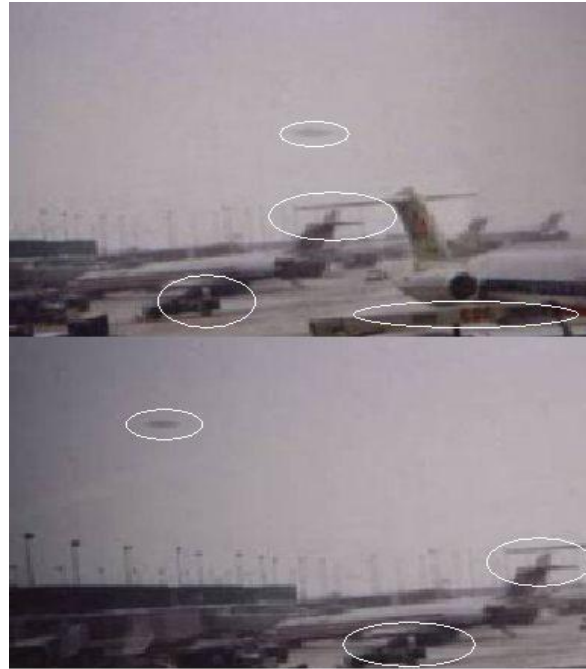
Figure 37. Hoaxed Photo at O'Hare

Many of these hoaxes have been revealed by sharp-eyed internet surfers who can find source photos on the internet and compare them with alleged incident photos. The picture above is actually a hoax that was resolved by comparing a photograph of O'Hare terminals found through an internet search with that of the alleged photo of the incident. It is clear that the original image had simply been rotated side-for-side and a UAP inserted, all done with the help of common computer imaging software.

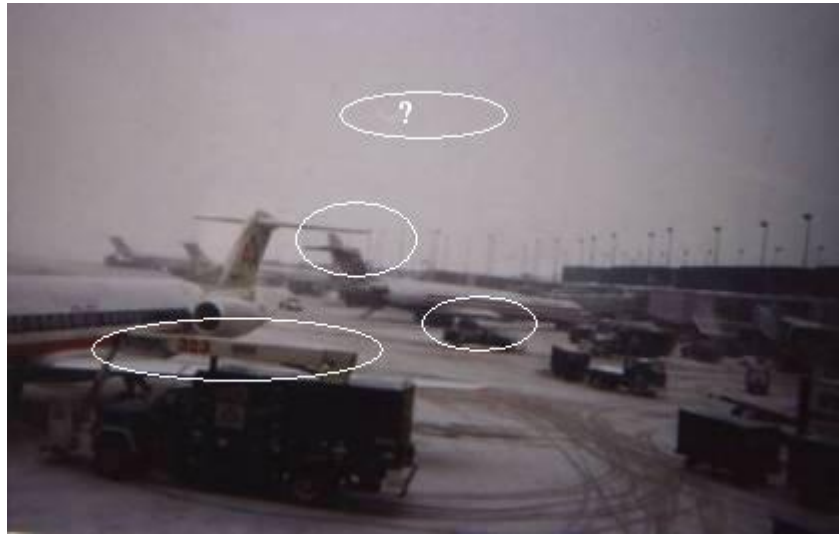
Figure 38. Original (Reversed) Photograph that was Modified
